CITY OF
ST. CATHARINES

Corporate Report

Report Number: TES-286-2013

Subject: Rennie Park Grading

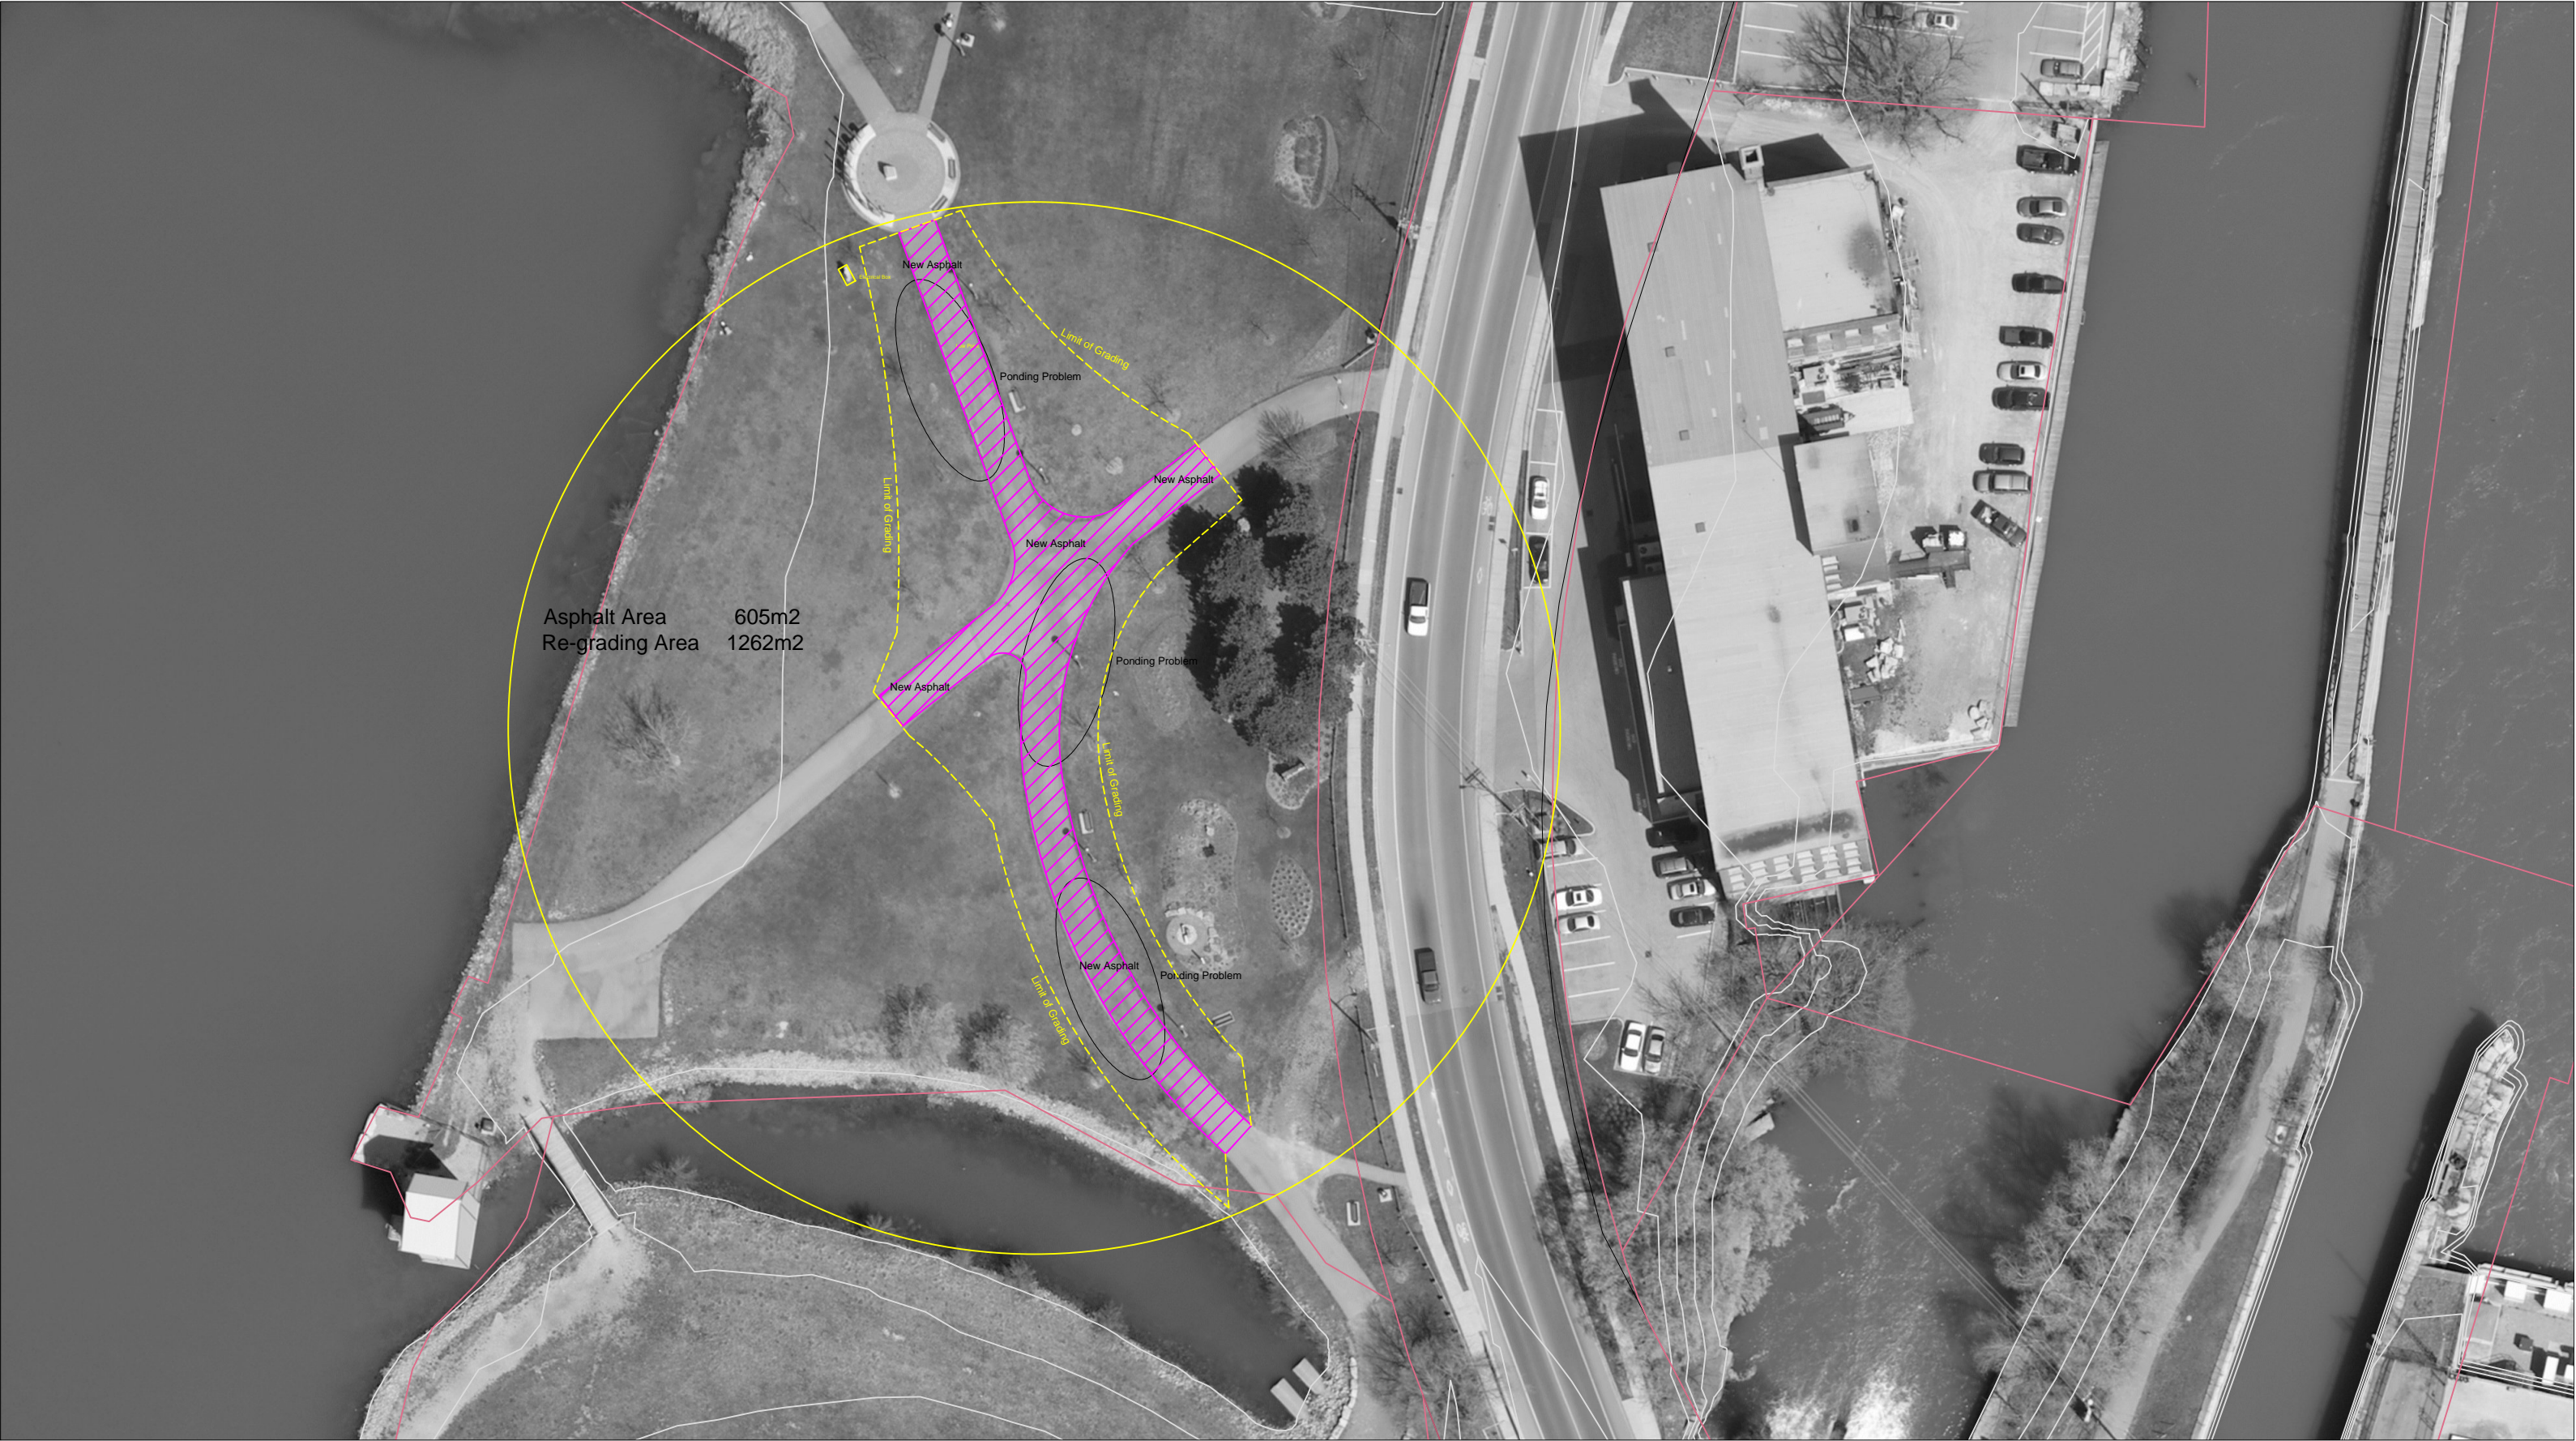
Rennie Park Drainage Improvements

Through time, the dredged material used to create the park has settled unevenly. The path of concern is used as a driveway or for parking vehicles during rowing and other special events. The path has settled more than the grass areas abutting the path creating an opportunity for water to pond. Because of the ponding, the asphalt surface has deteriorated.

RCS and TES Staff arranged for topographic survey and considered several options to address the concerns. Staff recommend approximately 150 metres of path should be raised a maximum of 600mm to create the elevation changes necessary to allow for satisfactory drainage. A sketch, Appendix 1 attached, indicates the approximate location of the proposed construction. To raise the area fill must be imported. A preliminary cost estimate for the proposed construction is \$70,000.
