Corporate Report

Report Number: PBS-287-2015

Subject: Recommendation of the St. Catharines Heritage Permit Advisory Committee (SHPAC) and St. Catharines Heritage Advisory Committee (SCHAC)
Regarding Proposed Demolition of Pavilion in Lakeside Park (9 Main Street)

Lakeside Park Picnic Pavilion

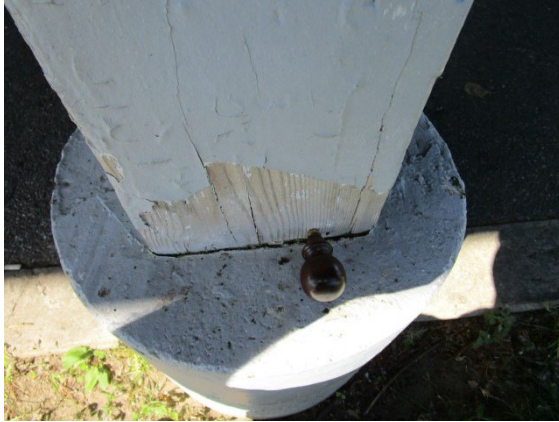
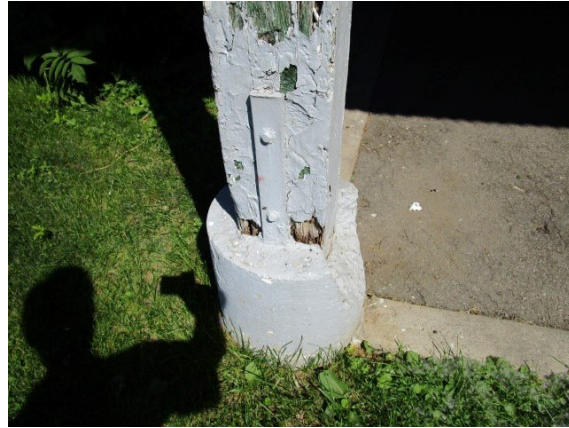
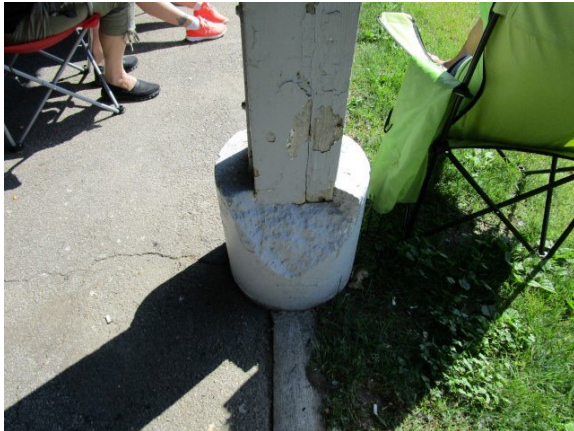
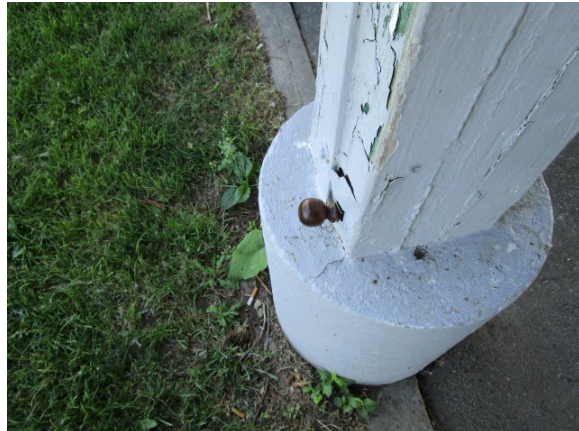
The original 8x8 Douglas fir wood columns were anchored to the 16" diameter concrete piers with two cast-in-place steel straps and steel lag bolts and the bases of the wood posts were poured into the top of the piers. This created a pocket that held moisture, resulting in the bottoms of the posts rotting off. A second consequence of the pockets was the retention of water that froze and split the top of the concrete.

Eleven columns have previously been repaired with spliced-in lower sections of pressure-treated 8x8 and five columns are badly in need of repair. Eight broken piers have been repaired with varying success, eight require repair, and the balance appear to be adequate however the presence of the recess in the top of the piers is a poor detail that should be corrected to eliminate future problems. None of the repaired columns have adequate fastening of the new wood pieces to the remaining section of wood post. All column splices must be straightened and retrofitted with hardware for proper stability, and all but seven of the original columns require wood repairs at the bases.

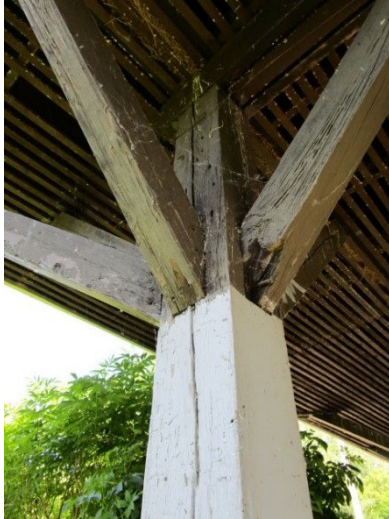
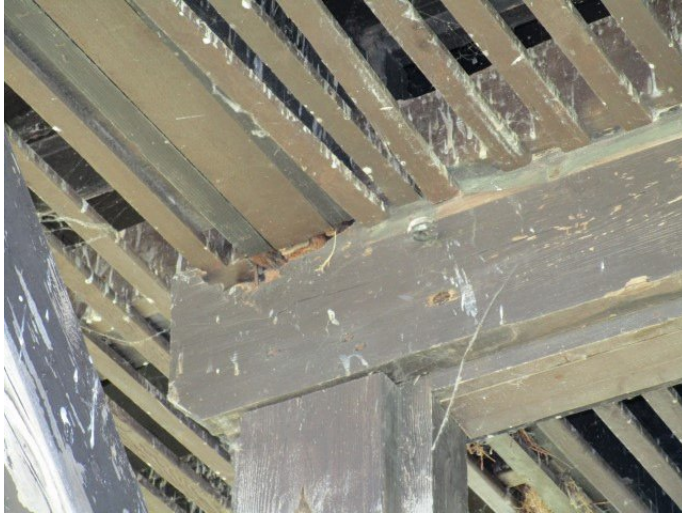
The columns carry built-up wood beams, and are braced with wood knee-braces to the beams and to the built-up trusses. There have been 2x4 pieces scabbed onto both posts and beams in various locations to reinforce deteriorated connections. Water has run down the braces and rotted the joints where they remained wet.

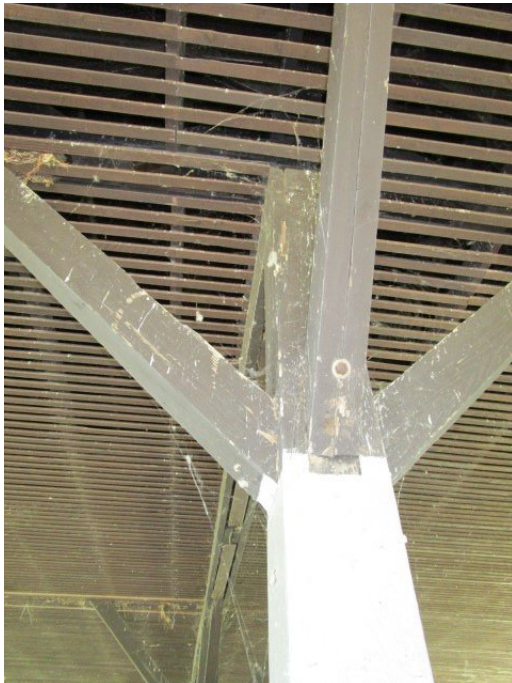
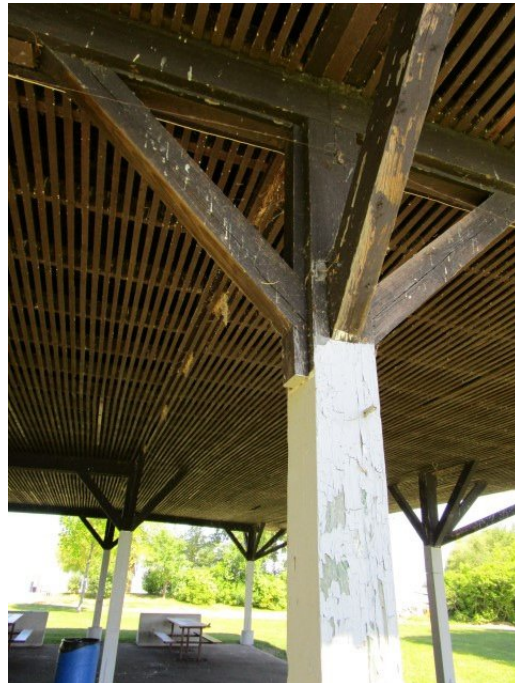
The top of some posts have rotted as well, presumably from previous roof leaks since there does not appear to be any leakage at present. Some braces had deteriorated to the point that they were replaced, using 2 - 2x6 instead of 1 - 4x6 as should have been done.

Lags to hold the replacement braces are located between the plies, rendering them ineffective.

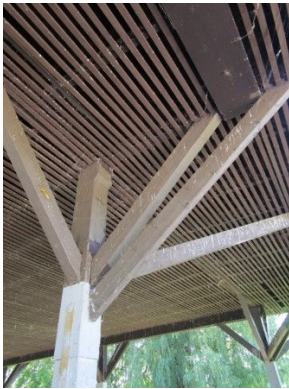
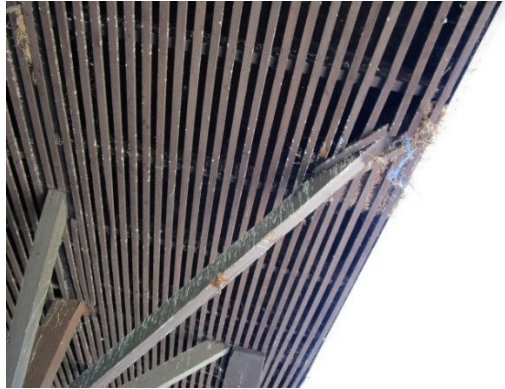
There are extra braces inserted into the ends to help support an extremely wide overhang, however the braces are at so low a pitch and poorly fastened as to be essentially useless.

The built-up roof trusses are inadequately sized and fastened. They have sagged badly and require jacking up back into alignment and reinforcement with new trusses sistered onto the existing ones. The multiple small members of the original trusses, beams, and braces were very attractive to birds for nesting. The addition of a slat ceiling exacerbated the problem, contrary to its intent. Not only is the fouling from the birds unsightly and unsanitary, the nesting materials contribute to holding moisture in vulnerable areas of the structure and either cause or increase the deterioration of the connections.

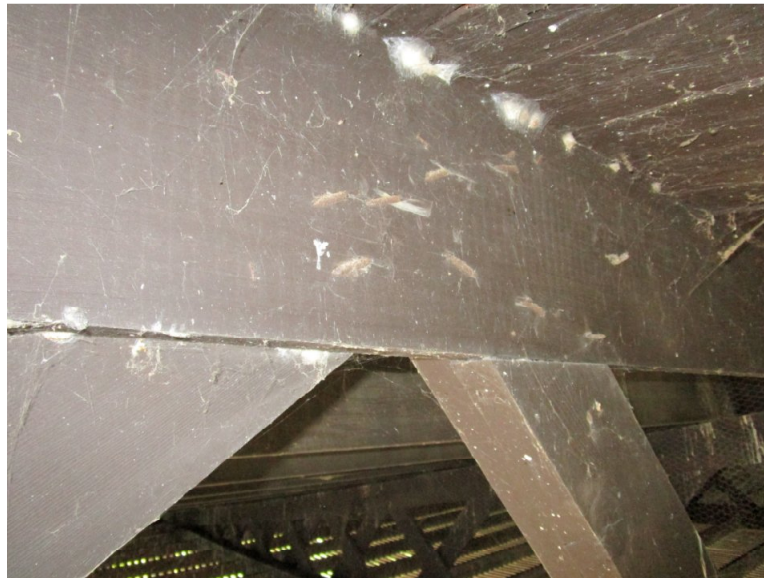
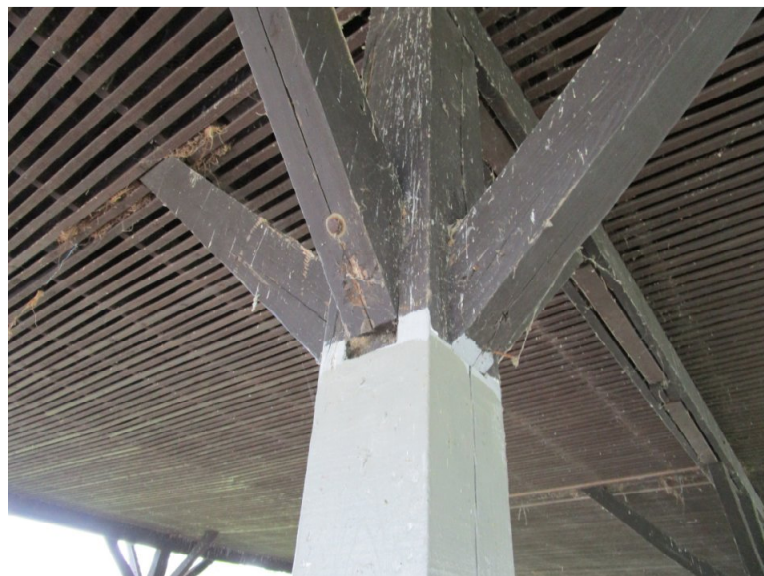
The existing roof trusses, purlins, and decking were made with new material, first assembled in the present configuration, and unaltered to today with the exception of minor repairs. The material is standard dressed dimensional lumber with square corners, indicative of a pre-1970 date. The vast majority of braces are also new material in their original locations. Most of them are square-edge, dressed 4x6 which is not a standard lumberyard item but is readily available. With the exception of a couple of easily detected replacements, the braces are nailed and bolted into the trusses and beams and could not be relocated without leaving obvious signs. One brace made of 2 – 2x6 instead of 1 – 4x6 and highlighted in our previous report as a replacement, is in fact an original brace. It is nailed to the ridge purlin and the nails have been clinched, however the bottom end is lagged with a hex head lag and it does not fit the mortice in the post.

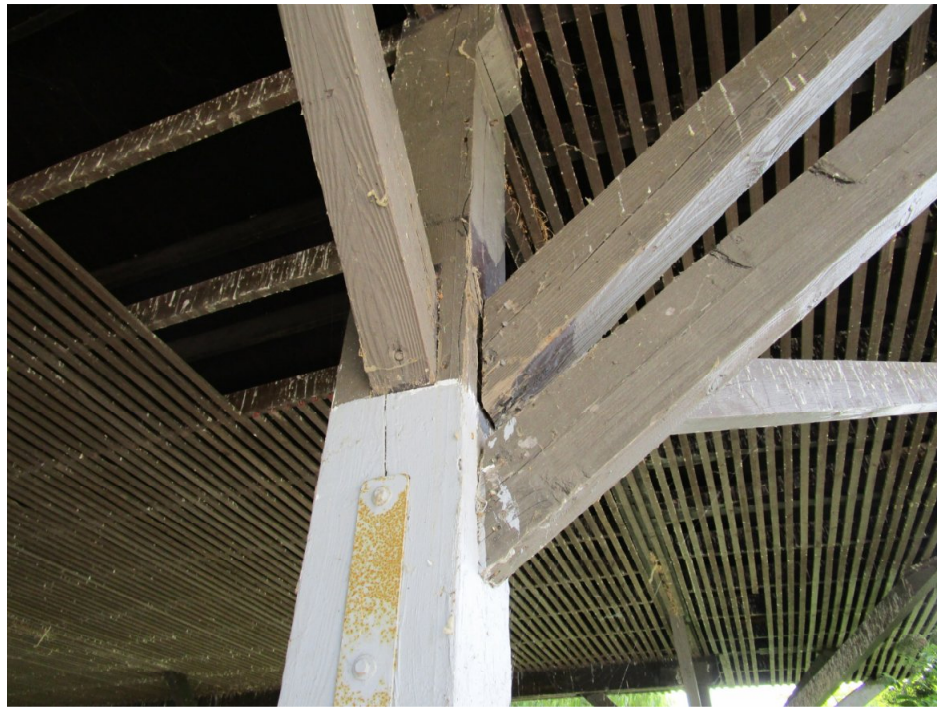
There are also 4x6 braces that do not fit the post mortices.

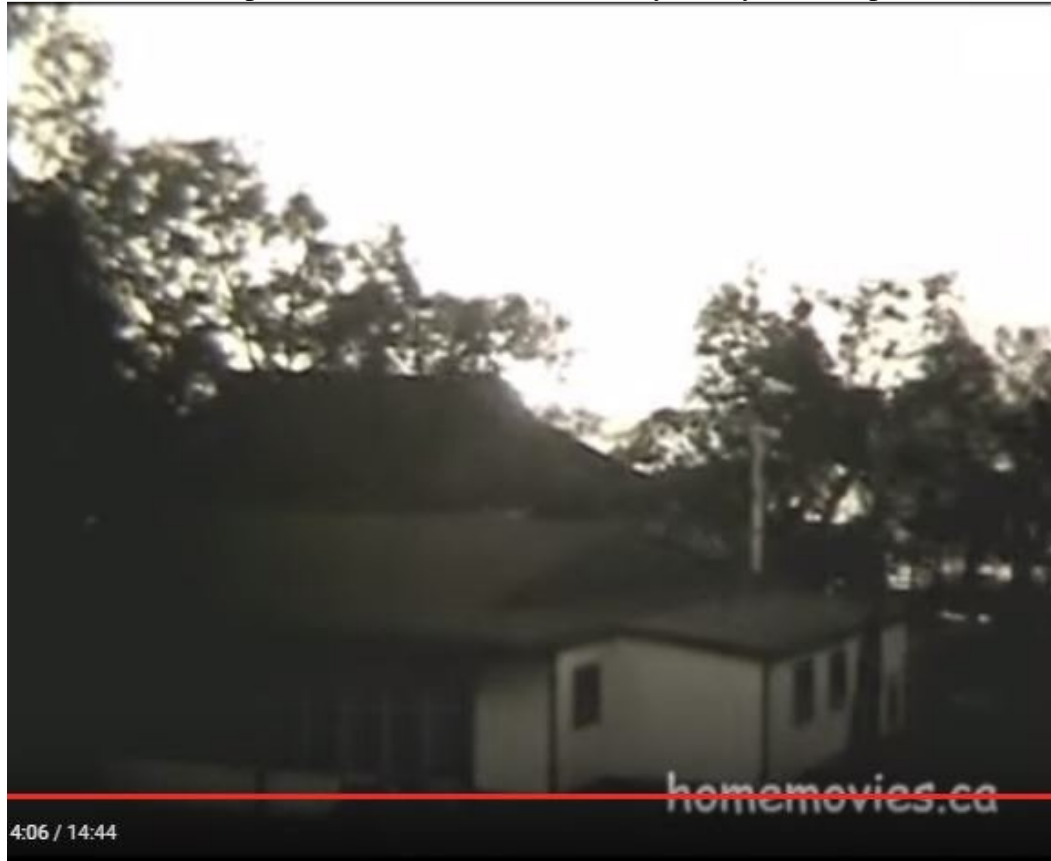
The truss bottom chords extend out through the fascia. The end grain is exposed to the weather in a very vulnerable position, where roof water constantly drips over them. This makes them very prone to decay, however the existing truss ends are in quite good condition. It is very unlikely that a 1920s structure would show this state of preservation with no finish applied to the wood until a sprayed-on stain was done. The ends of the trusses are not visible in the movie shots.

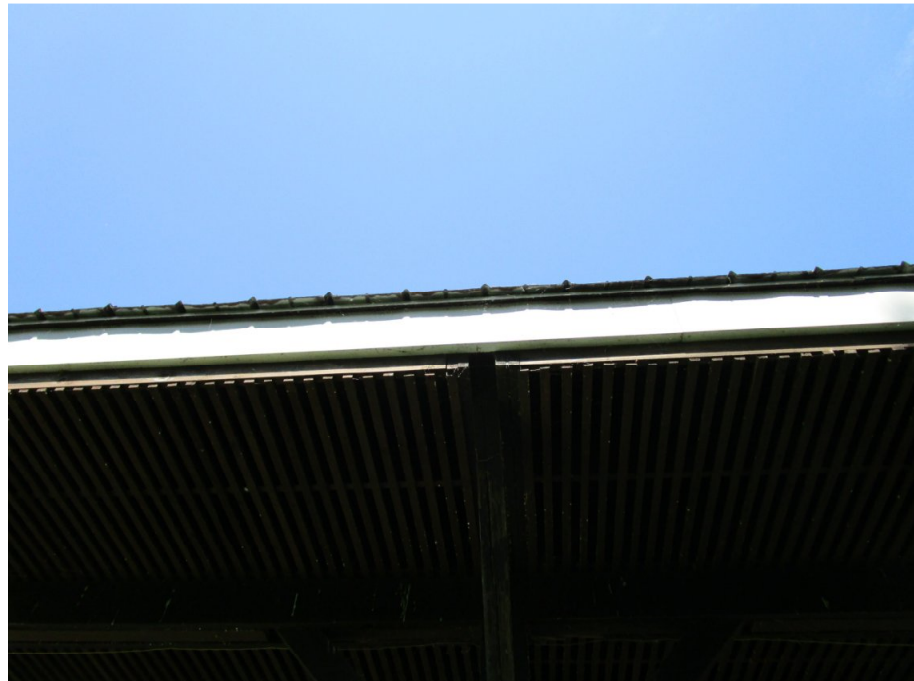
The existing ceiling of 2x6 joists and 1x3 slats is relatively new and can be disregarded as far as heritage fabric is concerned. The brown stain on it is a different colour than that on the rest of the roof structure, and the slats were installed with 16 gauge air nailer brads.

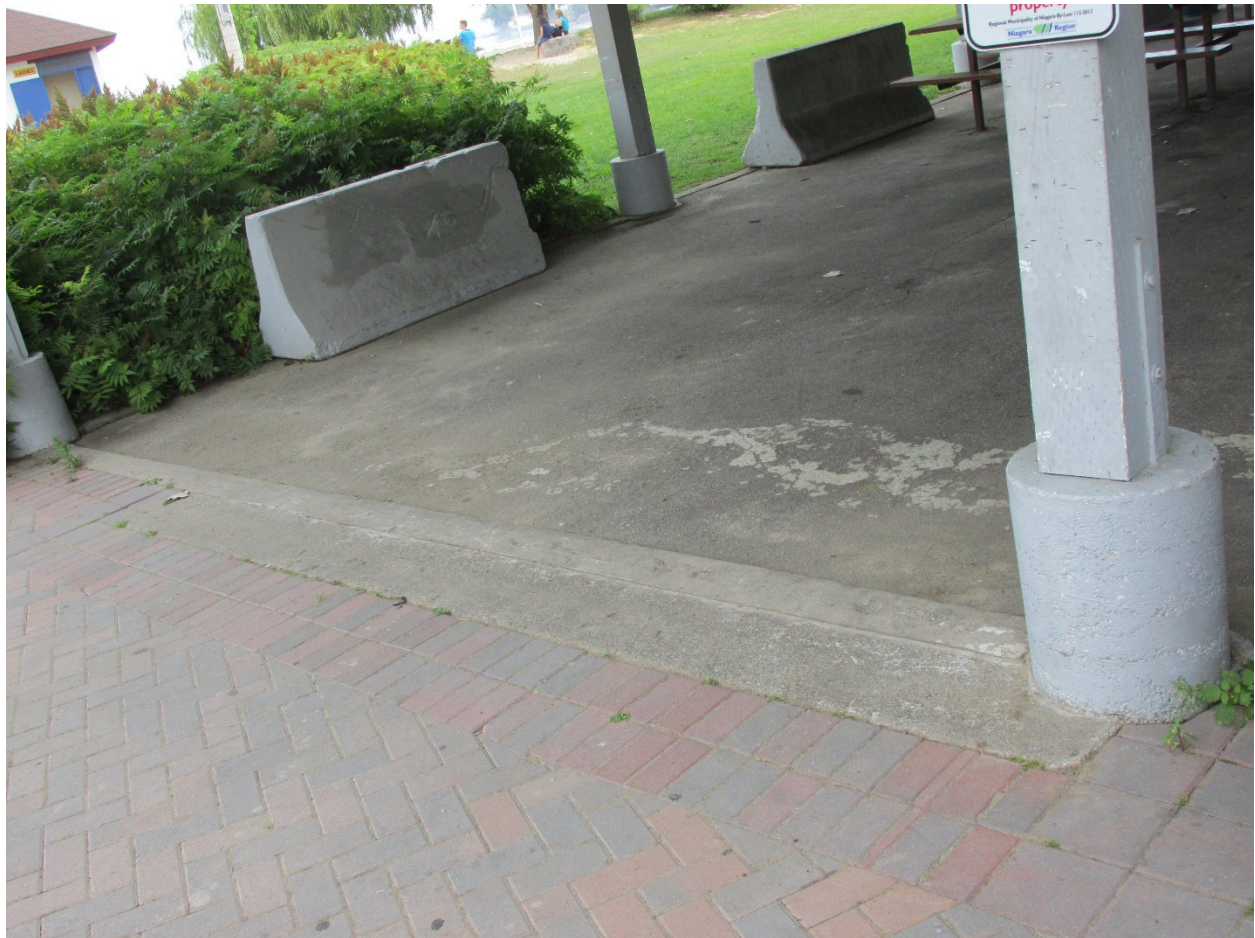
Figure 9

paving that may be part of the original decking. More significantly, two concrete pads along the west foundation are present in the same location as the stone/concrete entrance steps that appear in the Blue Note photograph. They mirror the entrance gaps in the west end railing perfectly. **(Figure 9)** These concrete pads serve no present day purpose, and are almost certainly the original steps to the wooden deck, now sunken, or footings for the same. A third identical concrete step or footing is located at the center bay of the north wall. This would indicate a logical entrance to the historic pavilion from the beach and dance hall nearby.

It is strongly recommended that the footprint or outline of the historic pavilion, and the three concrete steps be preserved as part of any renewal, and marking or delineating the historic entrance be considered.

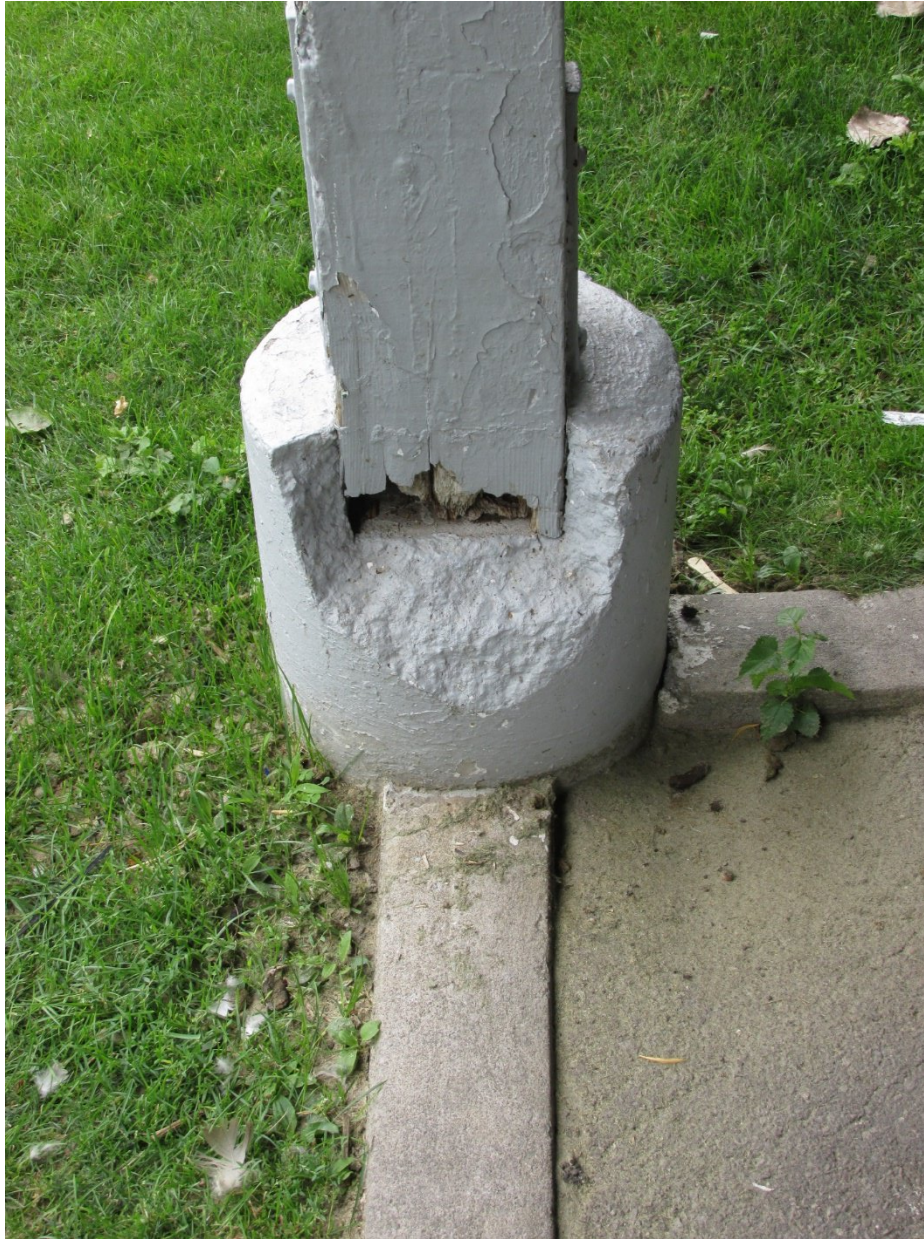
14 of the 26 posts appear to be old or original. All posts have had the bases cut and are now mounted on above-grade Sonotube concrete piers. Old material posts are set into the Sonotube concrete. **(Figure10)**

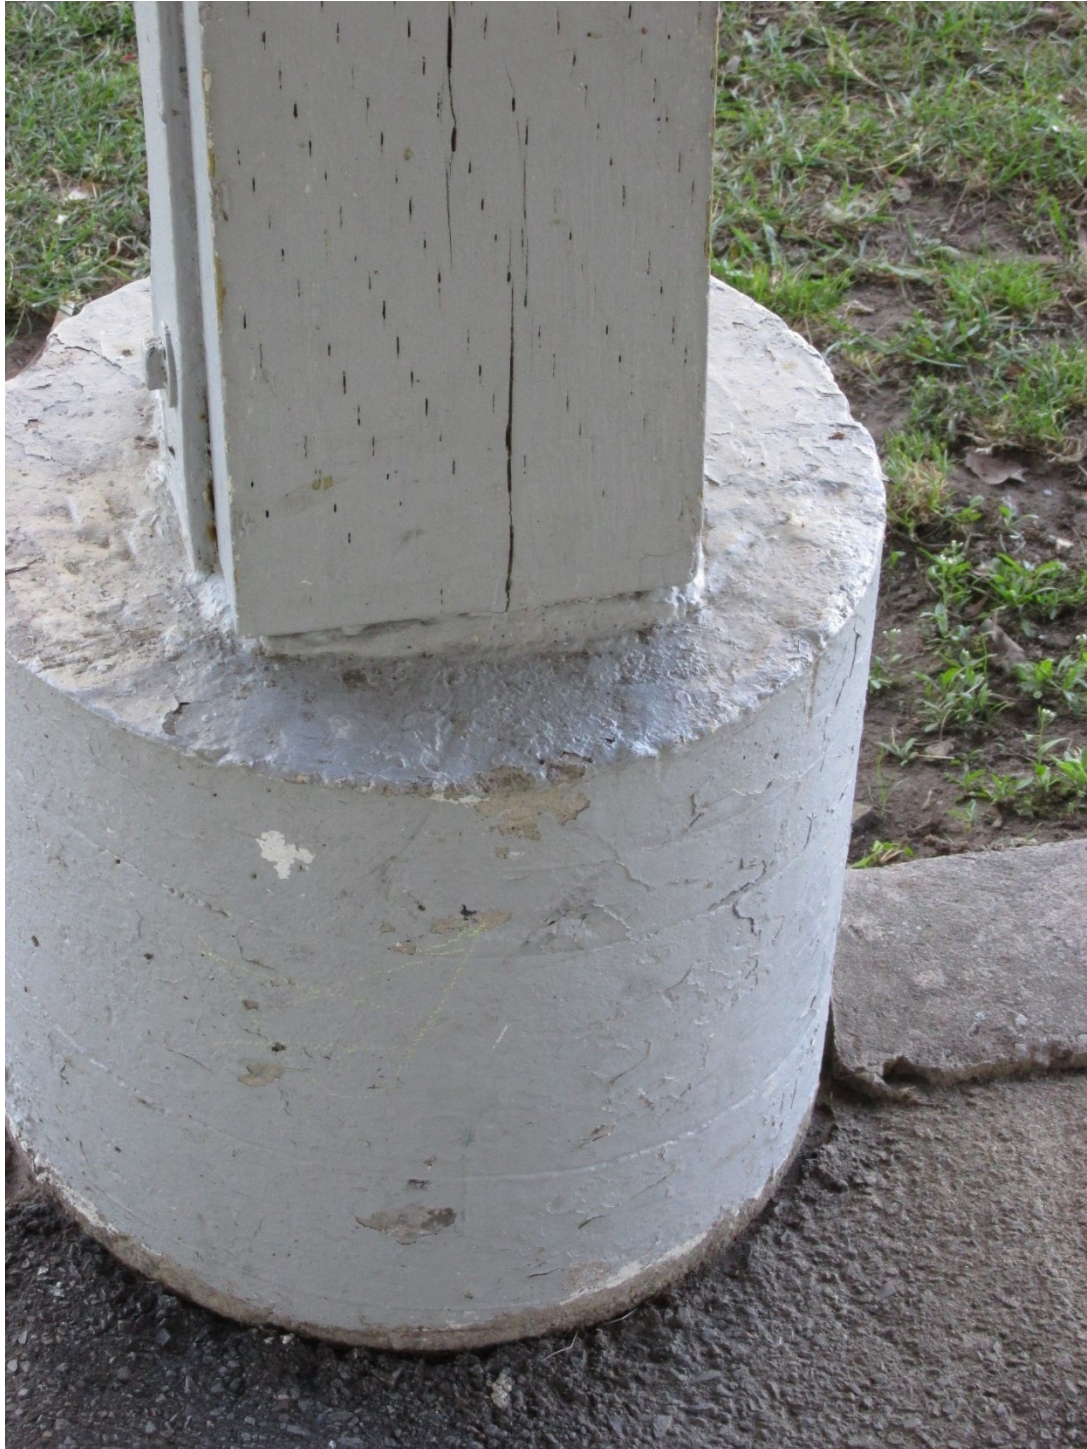
Later pressure treated post replacements are bolted on or above the tops of the piers. **(Figure11)** This may suggest an ongoing repair program, or two repair cycles.

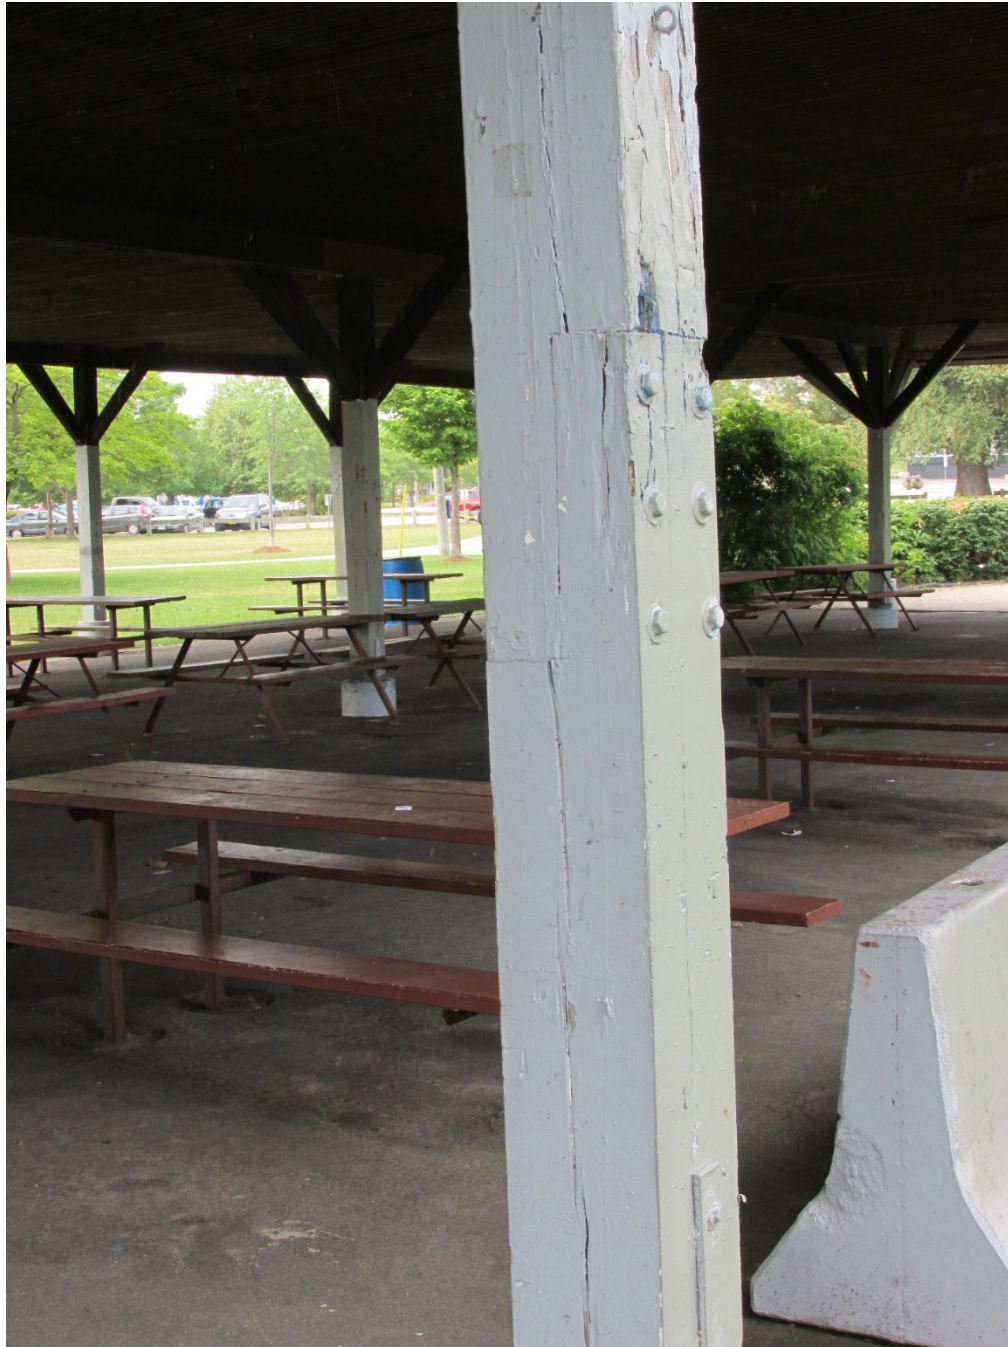
One additional old post has a half lap splice repair using old material. This may be an old repair, or it may be only visible instance of old material being added to the structure. The lower section does not have the paint shadows of the full restaurant exterior wall clearly visible above. This repair must have occurred after the pavilion restaurant was removed by the mid 1960's. **(Figure12)**

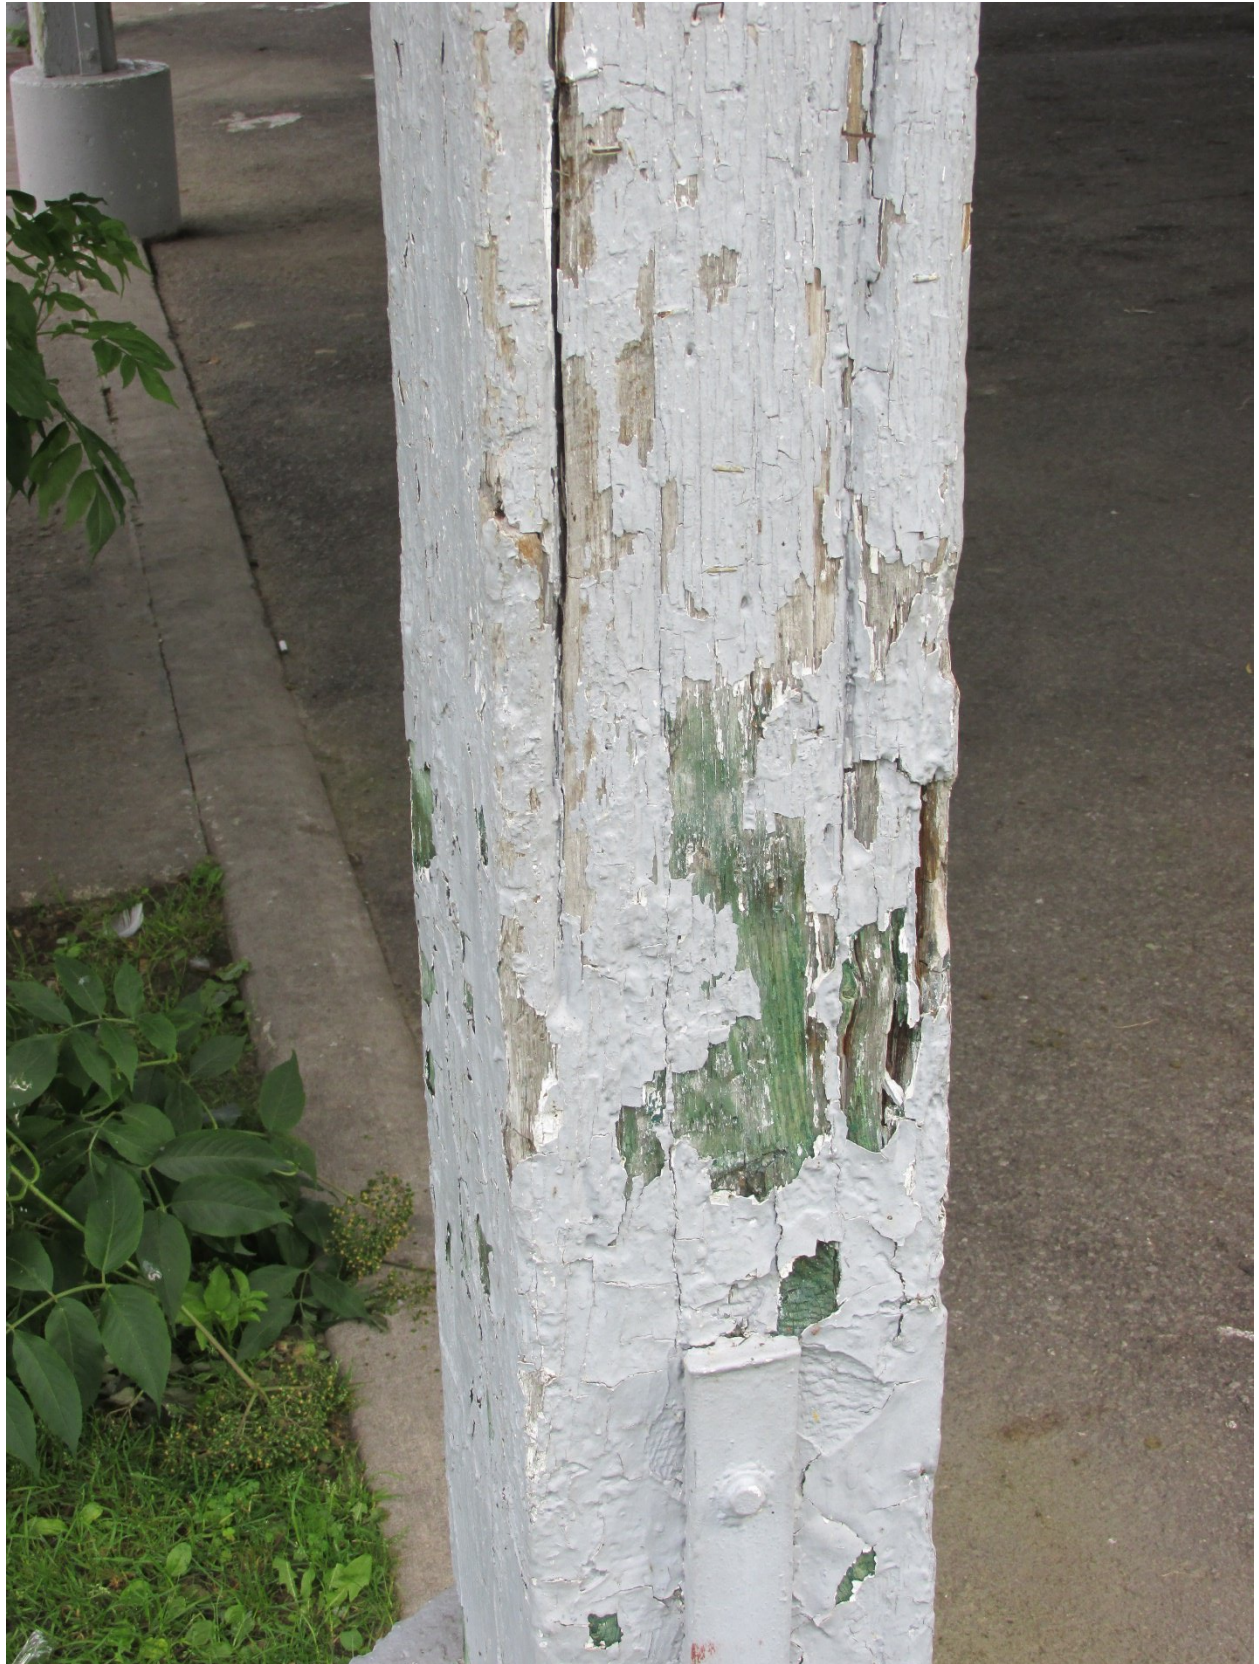
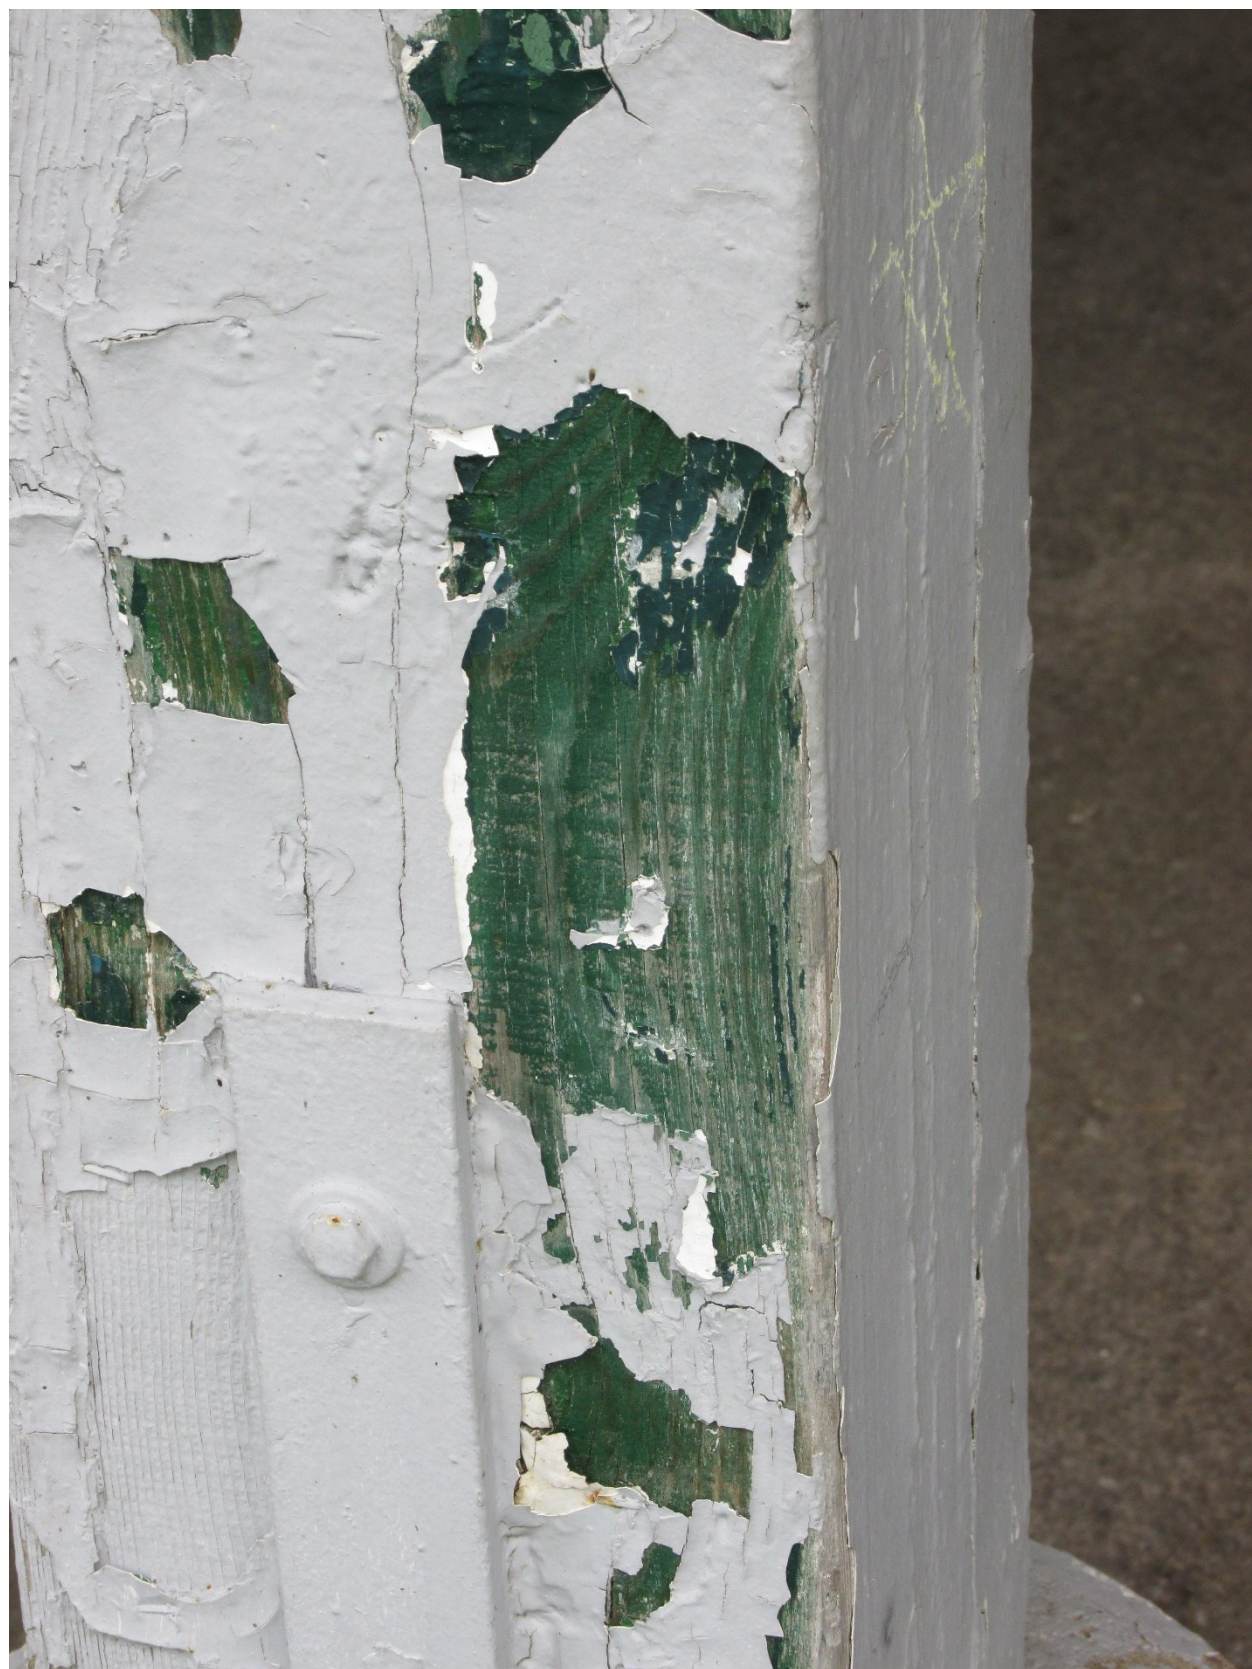
(Figures 13-14)

Nine posts have partial replacements with pressure treated material extending upwards from the concrete piers to roughly one foot below the knee roof bracing on the posts. Old material seems to be used above the knee bracing. Two posts are complete pressure treated replacements with old bracing material attached.

The pressure treated replacement post sections are slightly dimensionally smaller than the old material, and easily identified by the visible incising marks on surfaces. (These incising marks were used in the pressure treating process beginning in the 1950's). This material has been painted grey from the concrete piers to the knee bracing. The braces and posts above this point are painted or stained a dark brown colour. All old posts are overpainted grey. Most paint finishes are chipped and worn, and the paint layers easily examined without physical intervention. All pressure treated posts are painted grey, some with a white undercoat or primer. One pressure treated post has a light green coloured wood surface visible in places, evidently the CCA (Chromated Copper Arsenate) used in wood treatment.

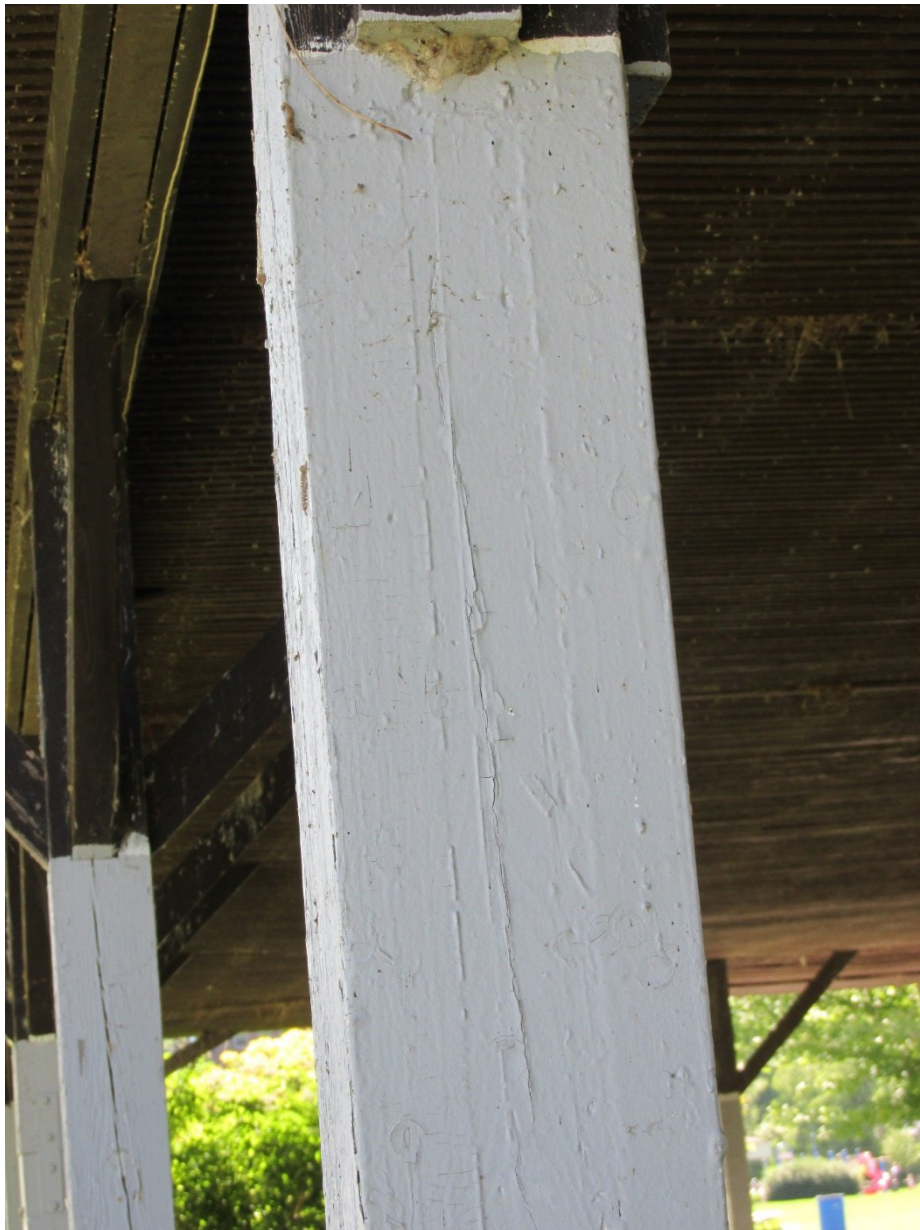
Old exterior posts on the east or restaurant end have paint lines showing the outline of a full exterior wall running between the posts, as high as the knee braces, enclosing the restaurant space. **(Figure 16)**

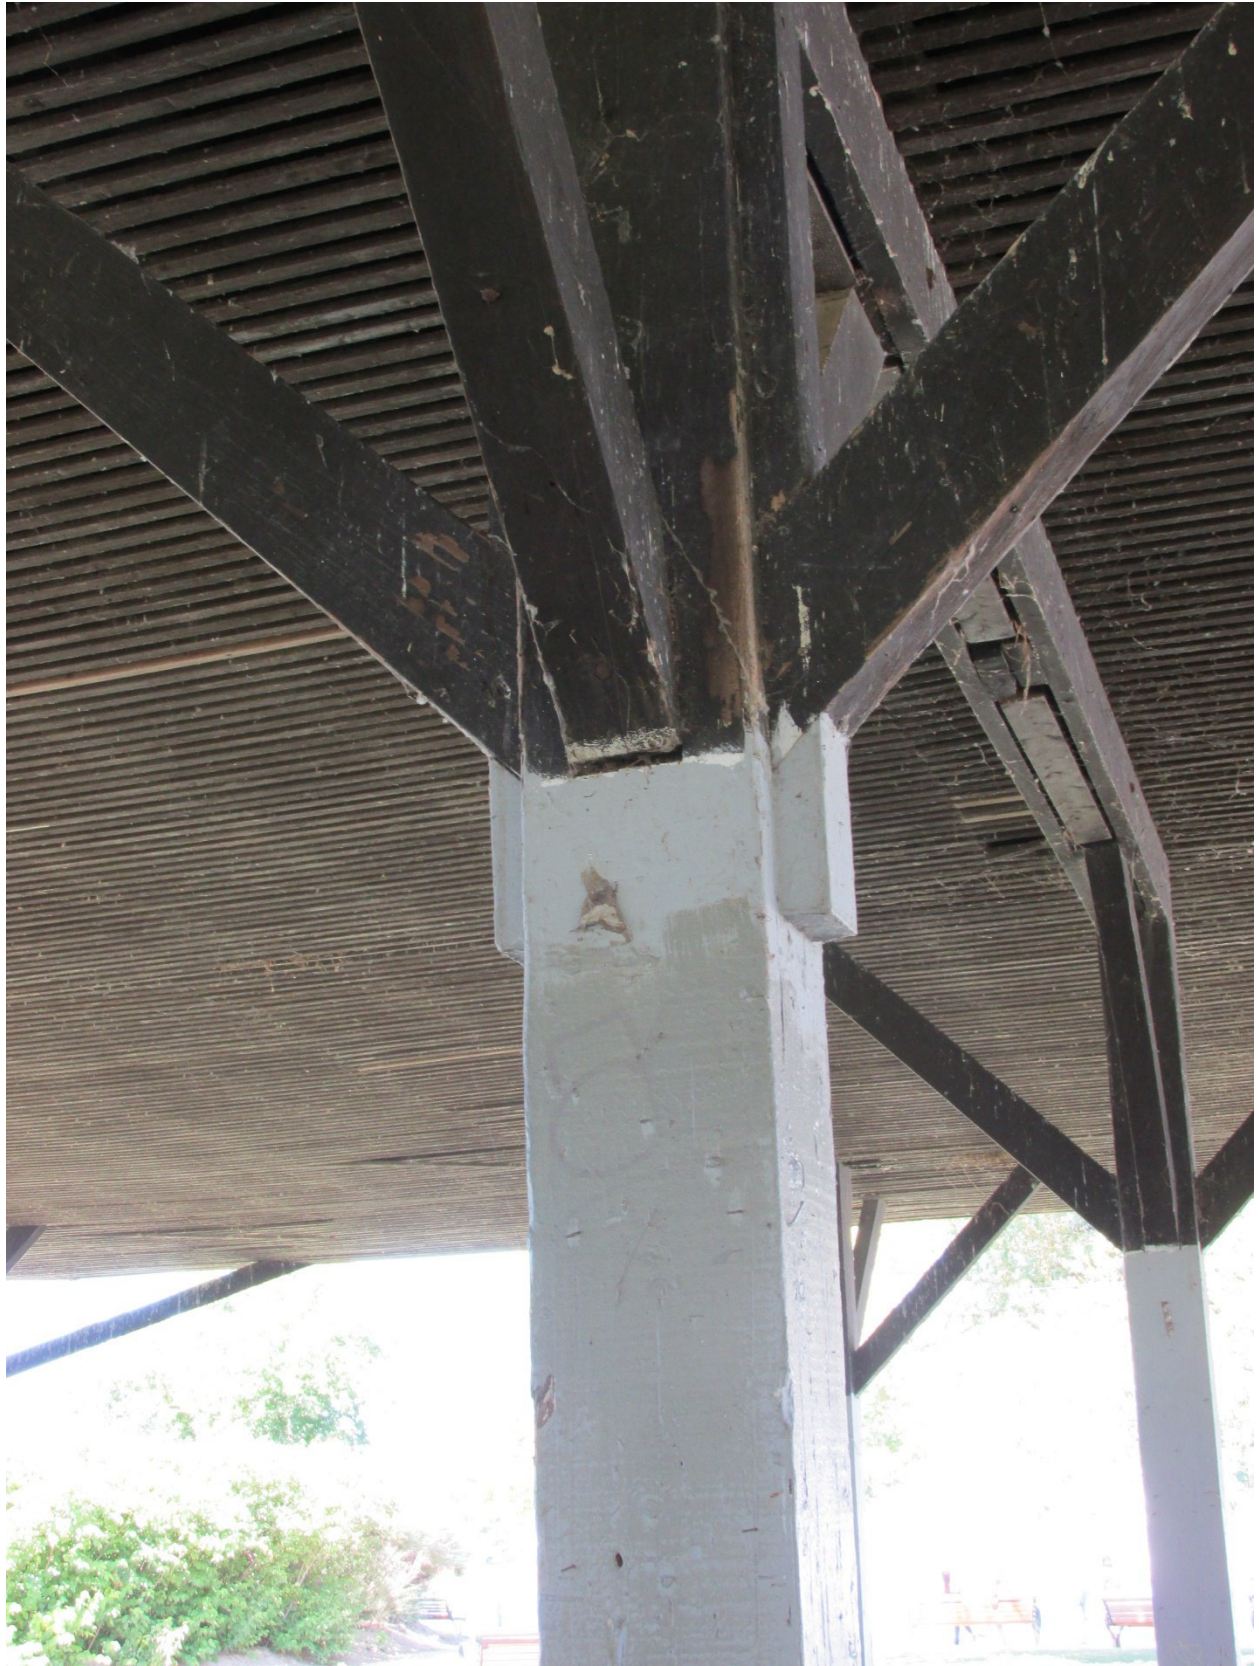
The interior partition wall with the serving counter seen in the Blue Note photograph has also left traces: 2" x 4" blocks are spiked below the knee braces on a north-south row of posts. These either supported or were part of a frame partition wall. **(Figure 17)**

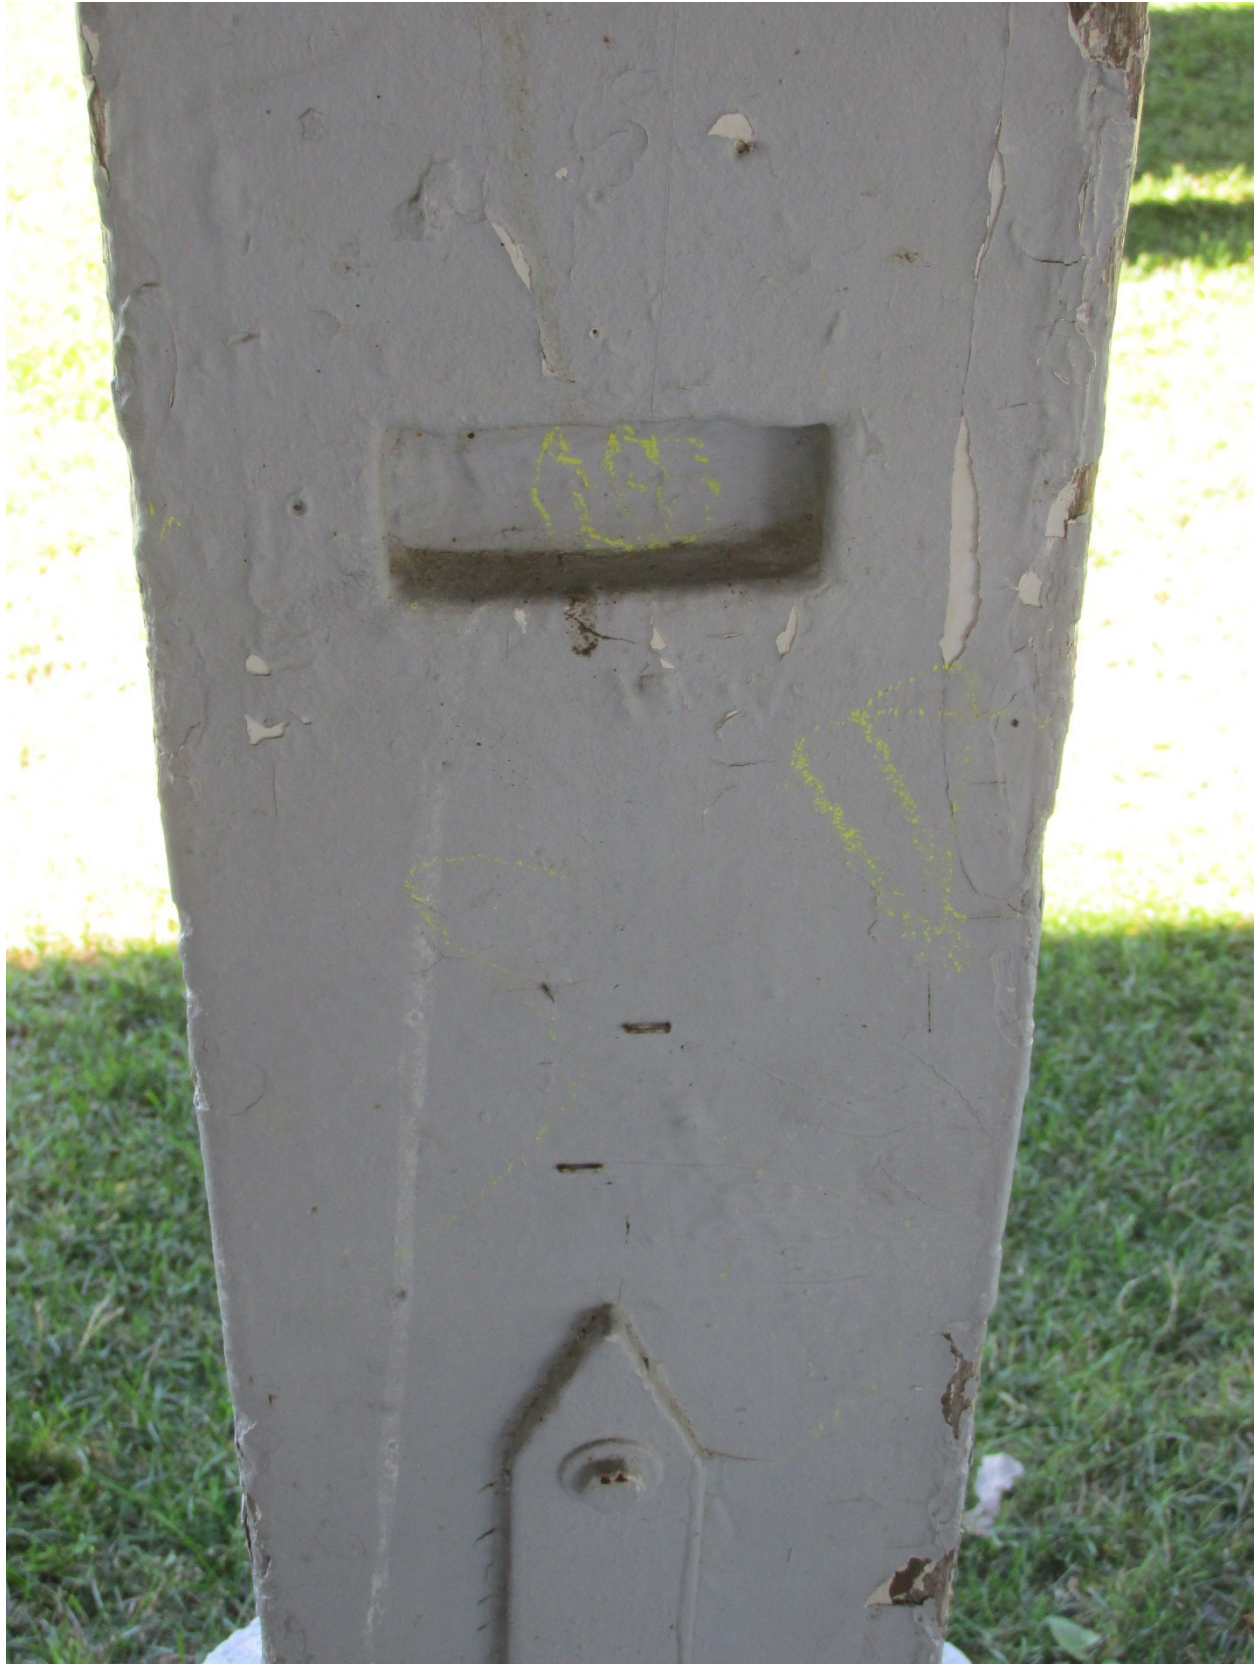
A second north-south range of posts has shallow horizontal rectangular mortise joints cut into them, all in the same location, at the same height. **(Figure 18)** This may represent an earlier or later counter not present in the Blue Note restaurant era, or perhaps the support for a work or serving table or storage rack system inside the restaurant.
