Corporate Report

Report Number: PBS-287-2015

Subject: Recommendation of the St. Catharines Heritage Permit Advisory Committee (SHPAC) and St. Catharines Heritage Advisory Committee (SCHAC)
Regarding Proposed Demolition of Pavilion in Lakeside Park (9 Main Street)

Lakeside Park Picnic Pavilion

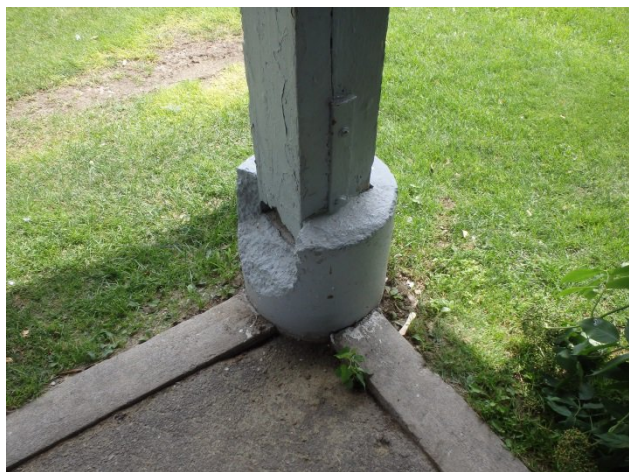
Figure 11 Support column detail

Later pressure treated post replacements are bolted on or above the tops of the piers. **(Figure11)** This may suggest an ongoing repair program, or two repair cycles.

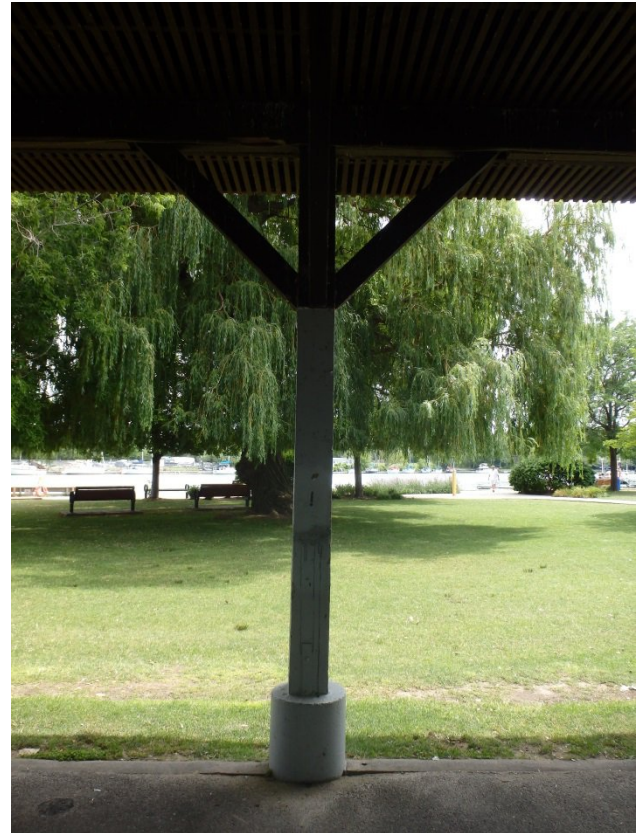
Figure 10 Support column detail

14 of the 26 posts appear to be old or original. All posts have had the bases cut and are now mounted on above-grade Sonotube concrete piers. Old material posts are set into the Sonotube concrete. **(Figure10)**

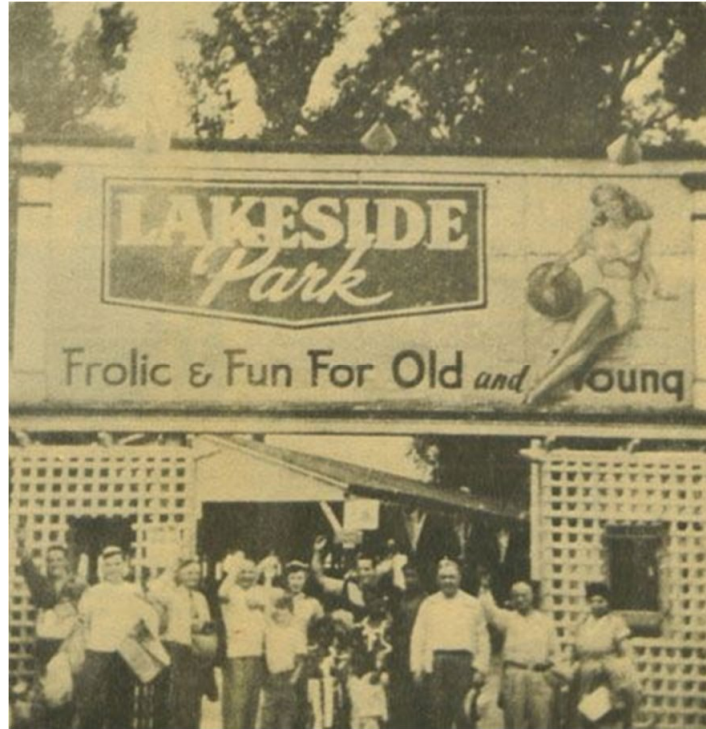
The caption describes it as the present pavilion without extended eaves. The pavilion in the photograph is not the present pavilion. It is not possible to extend the eaves of a building without lowering the fascia, which also lowers the ceiling level. The present pavilion ceiling is flush with the bottom chord of the trusses and the top of the braces throughout and the bottom chords of the trusses extend through the fascia. They have not been spliced and the roof plane has not been altered so it is not possible that it is the same pavilion as shown in the photograph of the entrance. This does not mean that the pavilion is not old, it simply means that this photograph is not of this pavilion.

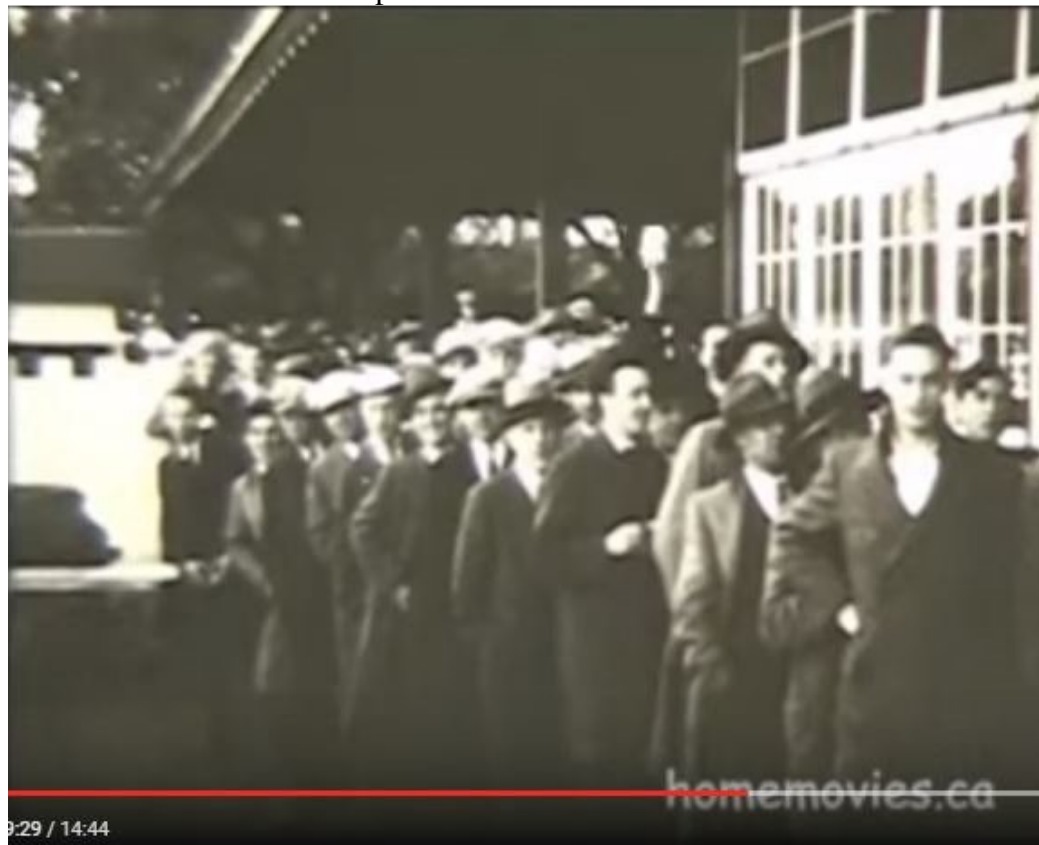
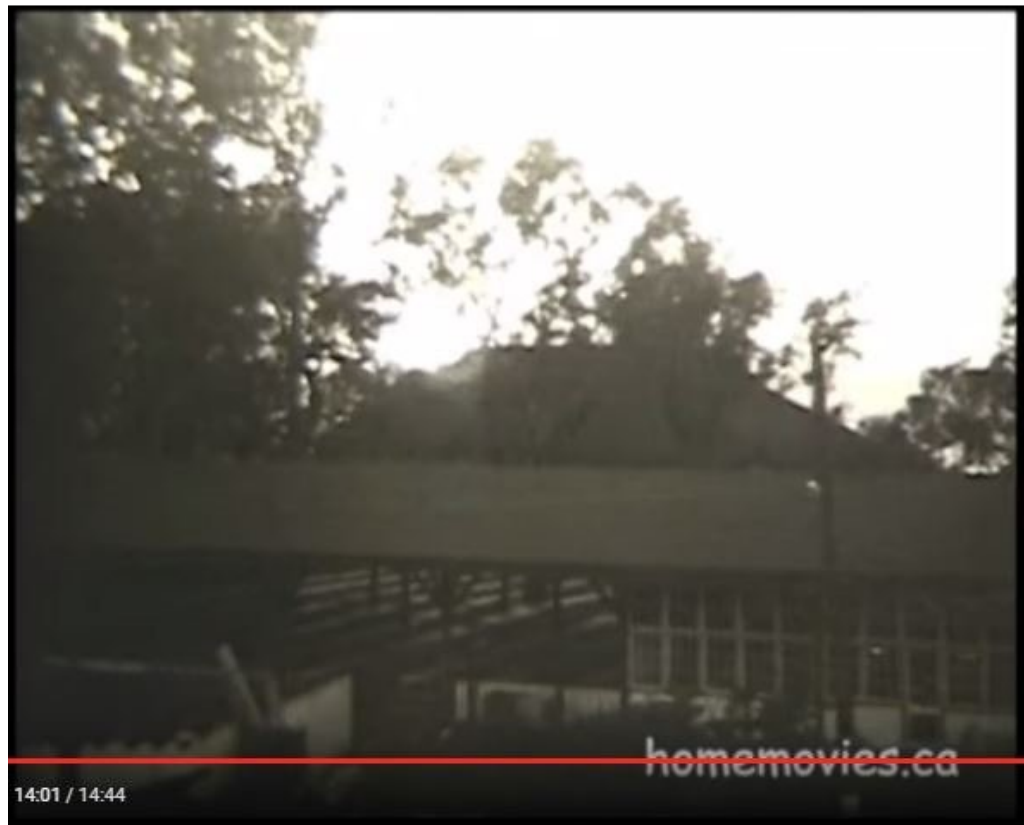
The braces in the east end of the building should show ghosting of the partitions visible in the Figure 6 photograph in the Webb report and visible in the Massey movie, if they existed when the partitions were in place. However, the braces are not visible in the movie, and it is not possible that they were added into the structure after the partitions were removed since the trusses were built with the braces in place.

The ghosting on the posts shows material fastened to them to just below the height of the braces, with no ghosting above that line however the 1929 movie shows a full height enclosure with no visible braces.

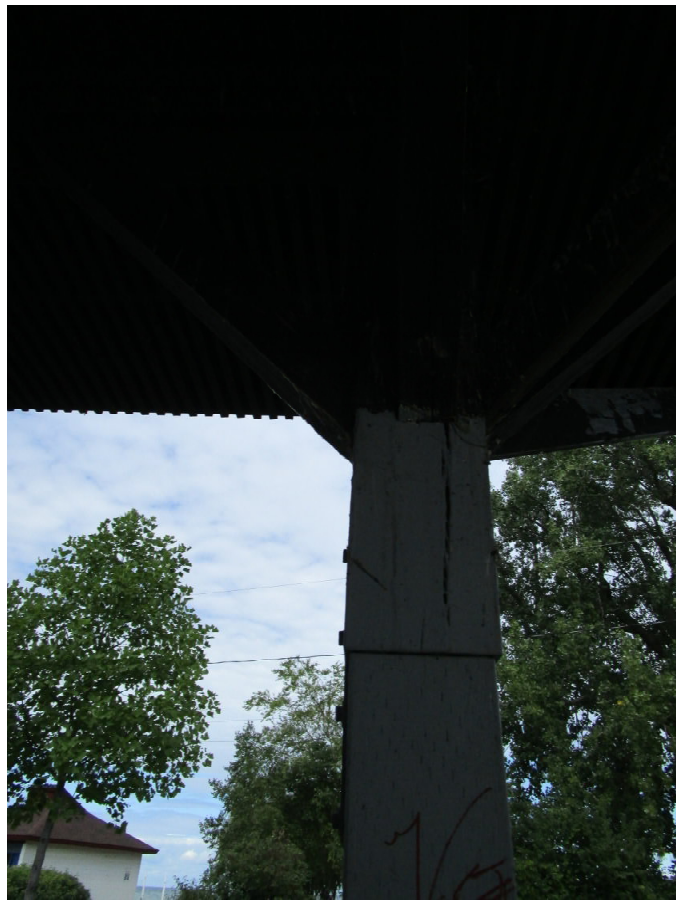
The northeast corner post shows ghosting of a possible partition in the paint, however the Massey movie shows an enclosure on the east than that would be very unlikely to have had a partition at the line of the posts. The addition extends only 5' beyond that point.

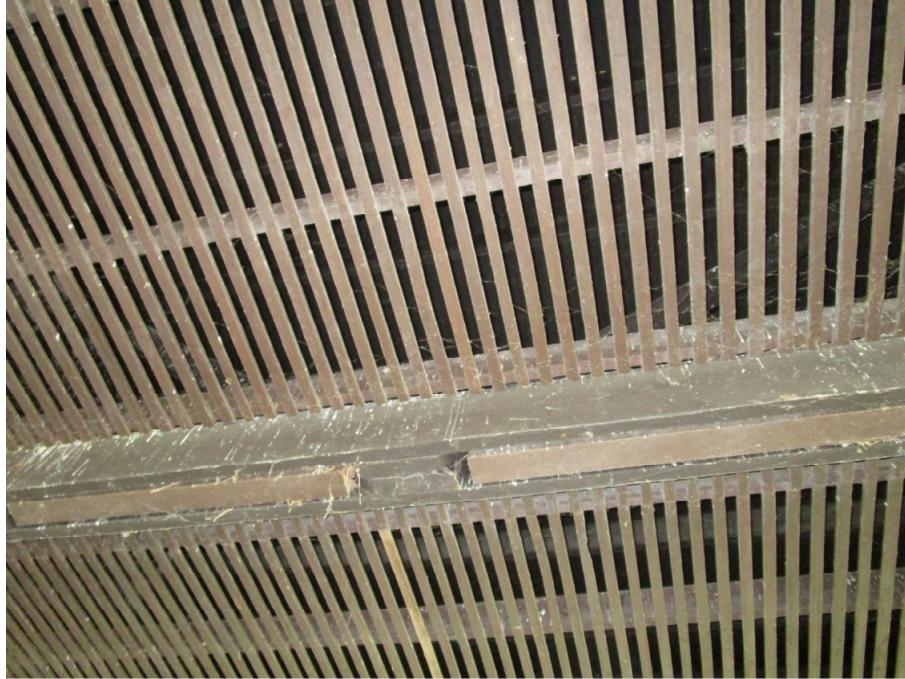
The trusses, purlins, and roof decking have had only one coat of finish, and it was spray-applied. This is most easily seen where a wood block was removed to install a ceiling joist.

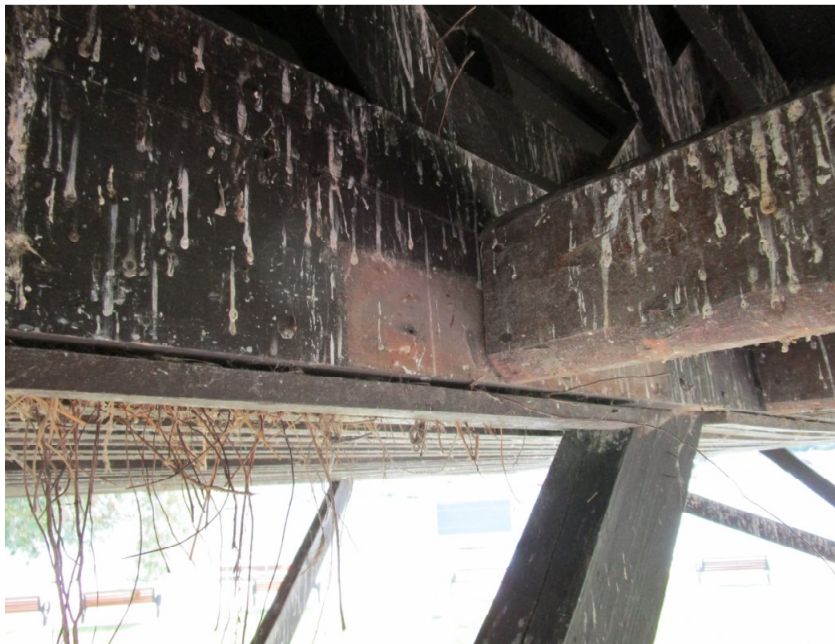
This is also visible where the spray onto the end gables was stopped by some remaining roofing along the bottom edge of the vertical T&G siding.

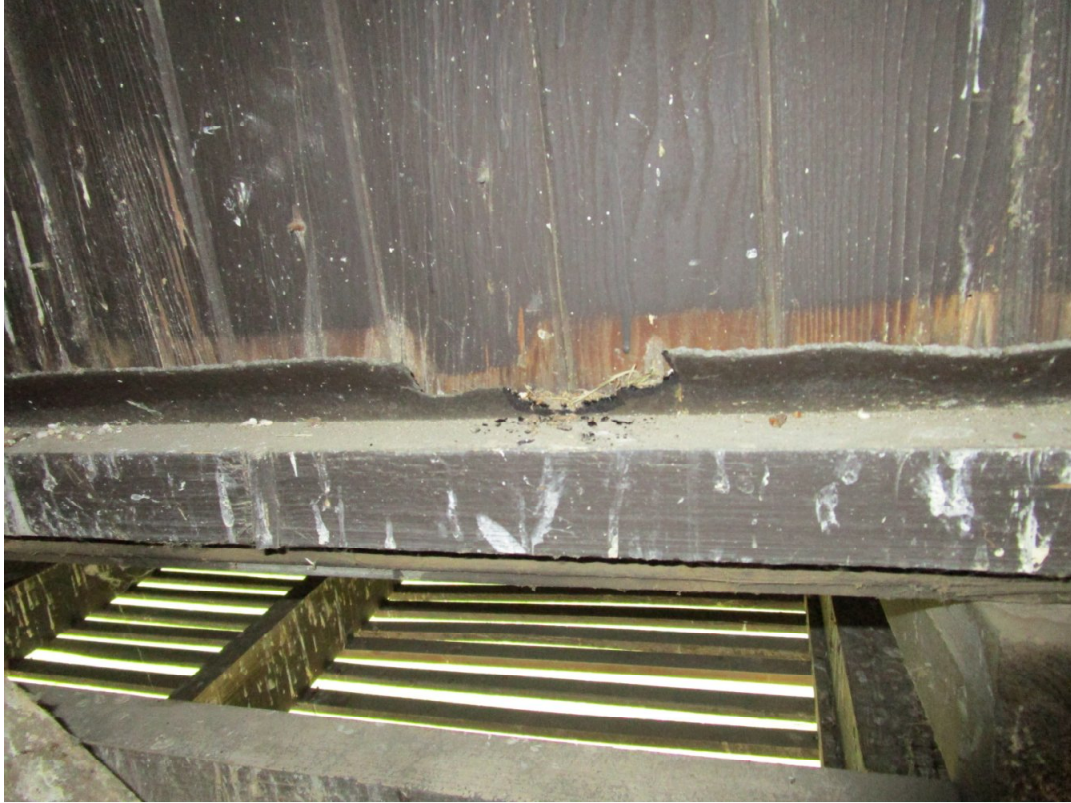
The roll roofing was installed on the end roofs before the vertical T&G was installed, making it self-flashing. The roll roofing was removed to install the present metal roofing, however the strip behind the siding remains. It was originally red.

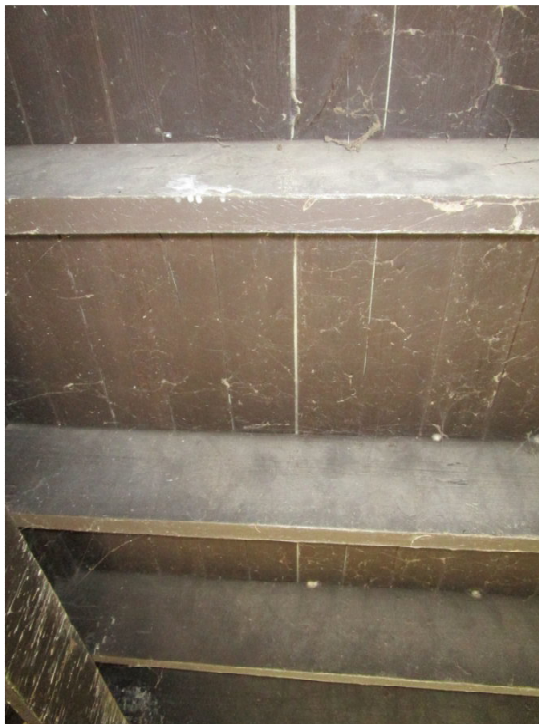
The 1x6 T&G roof decking shows no nail penetrations through the underside.

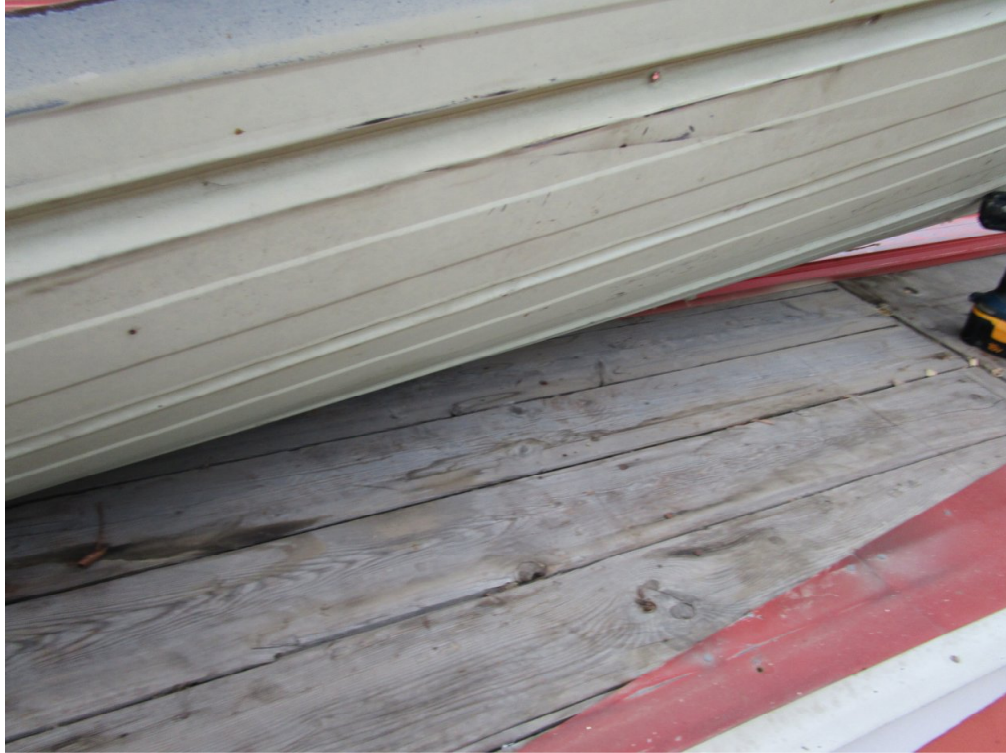
The top side of the decking shows only one set of nail holes under the existing metal roofing.

Roll roofing has a life expectancy of approximately 10 years. It was definitely installed on this building because traces of it remain. The existing agricultural prefinished steel roof is at most 40 years old, possibly only 30 years. It was installed with screws, which was uncommon before the late 1970s. It is inconceivable that an 80 year old building has had only one bituminous roll roof and one metal roof.
